POPPLINGTON HISTORIC STUDY

B-2740

101-125 S. Arlington Avenue

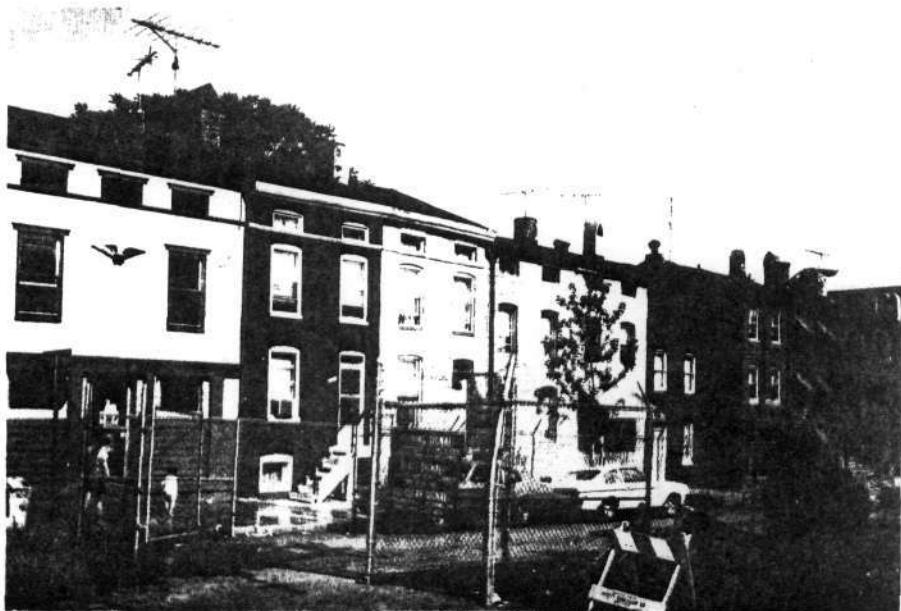
Number 101 has been stuccoed and remodelled; numbers 105-109 have been formstoned. Numbers 101-119 are shallow gable, 2 story and attic houses; the rest are slightly later, i.e., after 1851. This is a well tended, carefully repaired and clean street. Many of these houses have original stone foundation walls and cellars, hand-hewn floor joists showing in the cellars.

Lot (31) at 125 has been cleared and is paved parking for the envelope company just beyond. The street is now torn up and blocked by the storm sewer project for the expressway; blasting for it has damaged interiors of old houses, especially the stone cellars. Larger street trees are needed and more should be planted.
